## **SURVEY REPORT**

### **MAIN BUILDING STRUCTURE AND FABRIC**

Date of Report: 19<sup>th</sup> November 2009

Date of Inspection: 17<sup>th</sup> November 2009

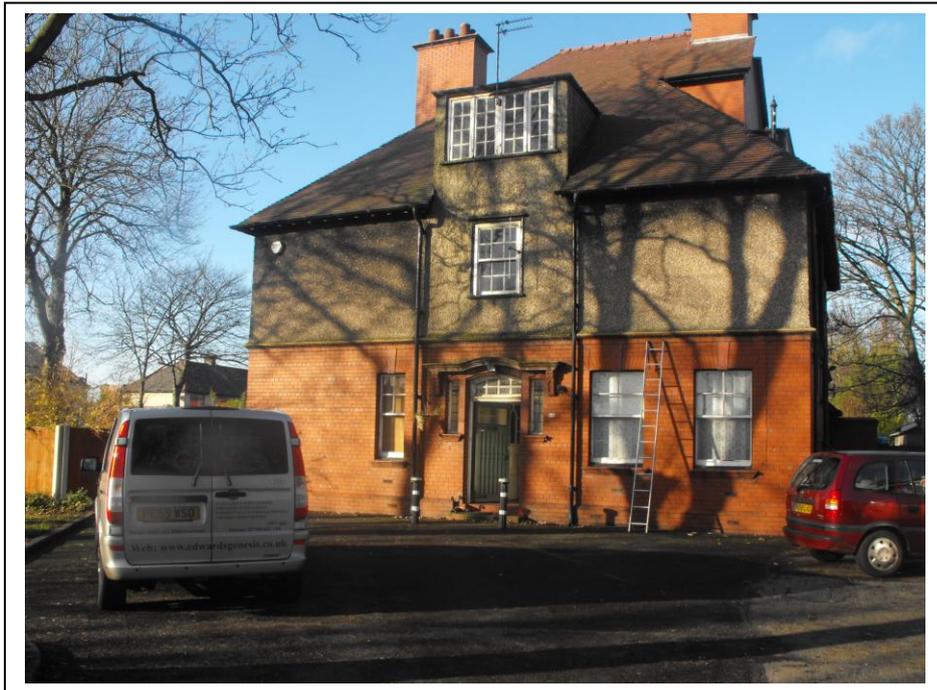
**Property** comprises a very substantial double fronted detached house with accommodation arranged on three floors and it was clearly purpose built as the Vicarage for the adjacent St John The Evangelist Church. A date mark on the projecting cornice over the front entrance door confirms 1908 as the year of construction.
