SURVEY REPORT

MAIN BUILDING STRUCTURE AND FABRIC

Date of Report: xxth November 2020
Edwards Genesis Reference: JB.AH 20/xxxx

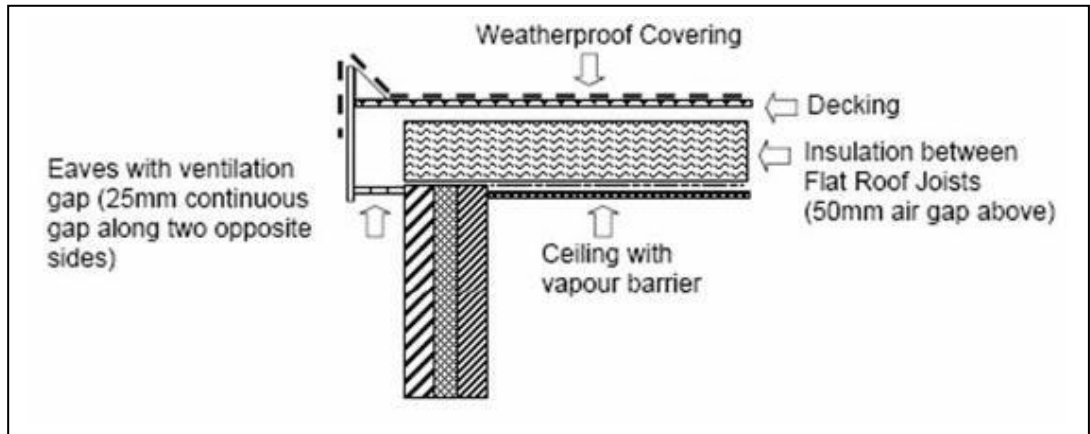
One of the problems with this method of construction is that moisture vapour from the internal accommodation can permeate through the ceilings, which are generally of plasterboard and, particularly if the ceilings do not incorporate any form of vapour barrier, can then condense on the underside of the roof deck, which will be extremely cold in the winter. This can then cause the joists and other timbers to become wet, particularly if insulation is saturated by the condensation, with a resultant risk of decay. Good design and construction will ensure provision of a ventilated gap between the insulation and the underside of the roof deck.
