Flat Buyer Report

Flat X, Bolton, BL1 XYZ

Report reference: 20/XXXX

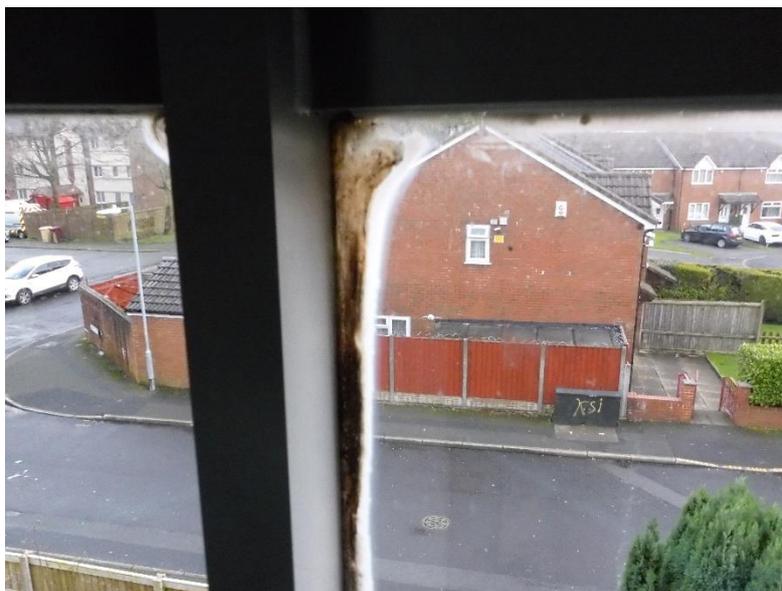
The windows are of wood grain uPVC. They are in satisfactory condition and where tested all opening lights operated satisfactorily. There are fire escapes to the bedrooms although escape via these will rely on the fire department having ladders of sufficient length. Your legal adviser should advise whether you will be responsible for the maintenance and replacement of windows in the future or whether the management company will carry out necessary works (section L3). I did note some signs of water marking and possible rainwater ingress to the large, timber windows above the front and rear entrance. The management company should be notified and carry out any necessary works. There is also some condensation mould visible around the windows of the subject property (see *Appendix C*). This should improve when the property is heated and properly ventilated. **CR2.**

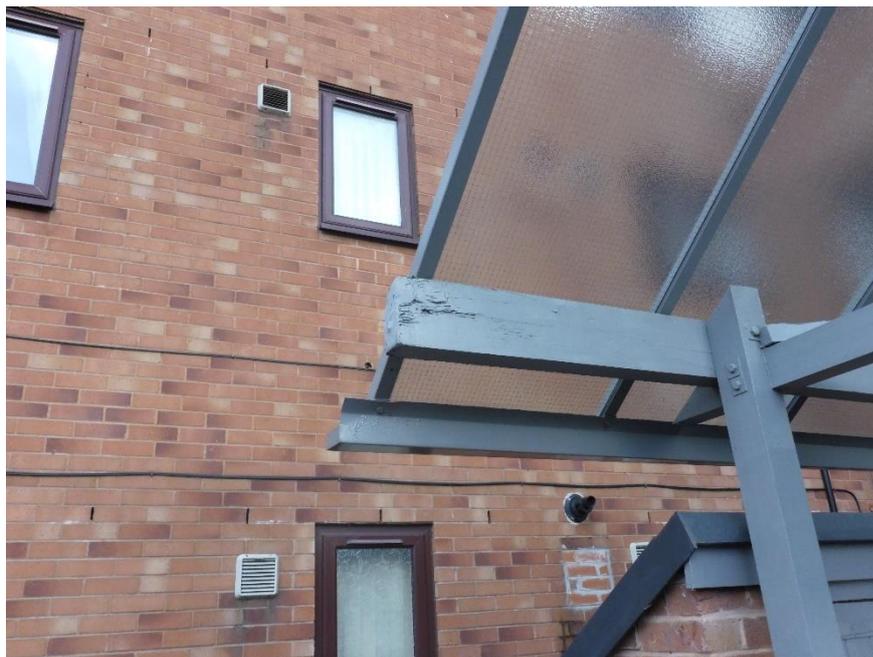
There is a timber and glazed panel canopy over the entrance walkway. This is in generally good condition. There is some weathering visible to the timber members of the roof and the management company should be notified of this. **CR2.**

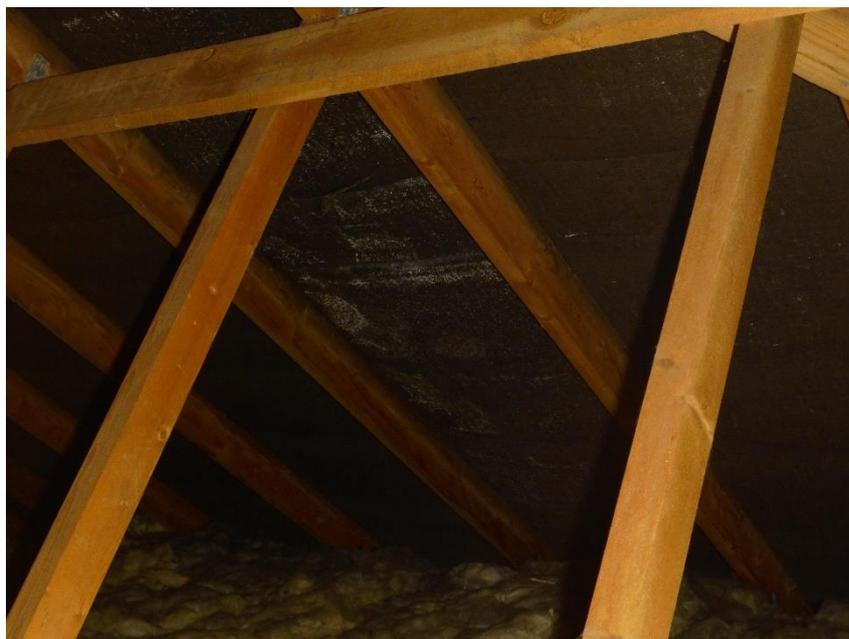
G1 Roof voids

Access to the roof void was via an insulated plastic hatch in the hallway of flat 10. The roof is of pre-fabricated timber truss construction. The trusses are evenly spaced and have a good level of bracing. I noted no signs of any racking or distortion to the roof structure. I also noted no signs of any beetle infestation. The underfelt is in generally good condition, but I did note some loose sections near the hipped section of roof. This should be repositioned. You may find that the management company will carry out these repairs as the roof is considered an element that is shared by all flats in the block. I found no signs of any rainwater ingress, but I did note some condensation mould on the underside of the felt (see *Appendix C*). This should be monitored for the time being and the management company notified. **CR1**.

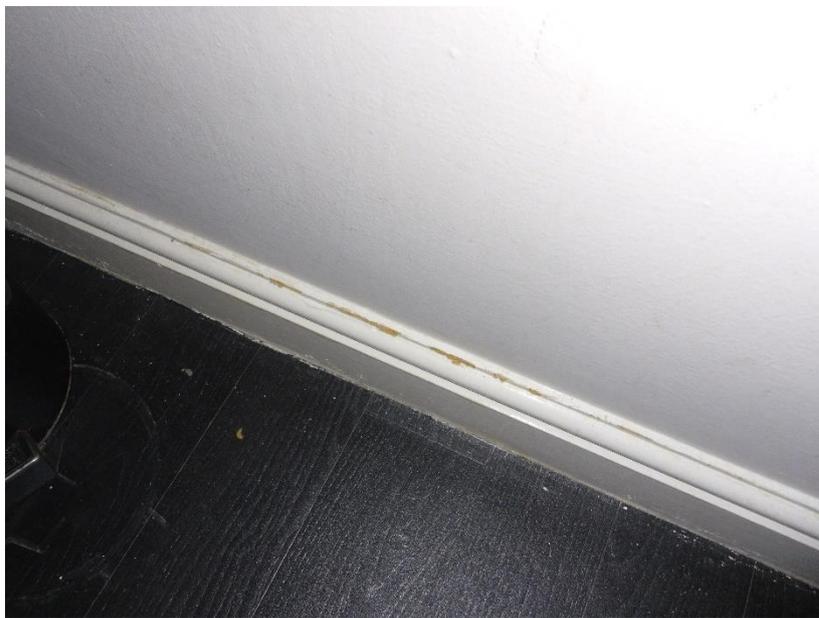
G3 Internal walls and partitions

The load bearing walls are dry-lined in plasterboard. There are some minor hairline cracks, but the walls are in generally good condition. There are lightweight partitions between rooms that are also in generally good condition. I did note some shrinkage cracks at the junctions between the ceilings and the walls. These cracks should be repaired prior to any future decoration. When using a conductance meter to investigate damp I noted some slightly high readings and visible water damage to the skirting boards in the bathroom. I am of the opinion that this has been caused by the splashing of water when using the shower, bath or any other sanitary fitting. **CR1.**

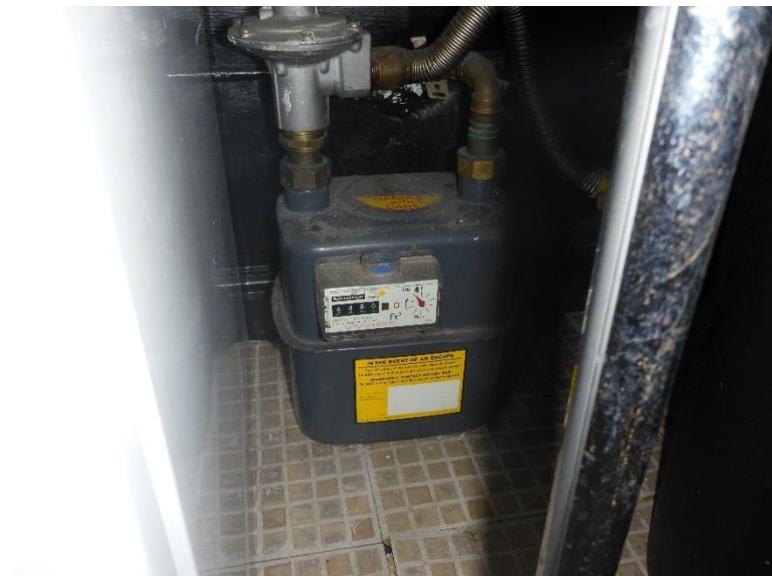
The property has a mains gas supply with the gas meter being situated in the kitchen. Although I have no reason to suspect any major issues I have not had sight of any relevant documentation and so a Gas Safety Certificate should be obtained **prior to purchase** unless the vendor can supply this documentation. **CR3 subject to documentation.**

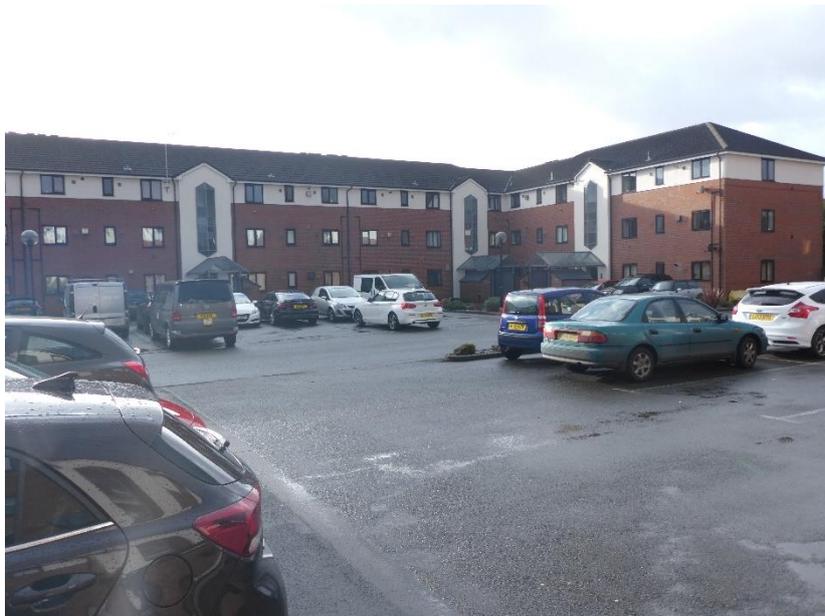
I3 Grounds – note these are **NOT** given a Condition Rating

There is a large parking area with undesignated parking spaces to the front of the property. There are some lawned areas to the rear of the property with neatly bordered lawns and planning beds.
