Condition Report

Benchmarked to Level 1 RICS Home Survey Standard June 2020

Client: Client (see Copyright Notice on page 5)
Surveyor: John Brownlow MRICS FISVA
Date of inspection: 29th November 2023
Date of report: 30th November 2023
Report reference: JB/AH 23/*****

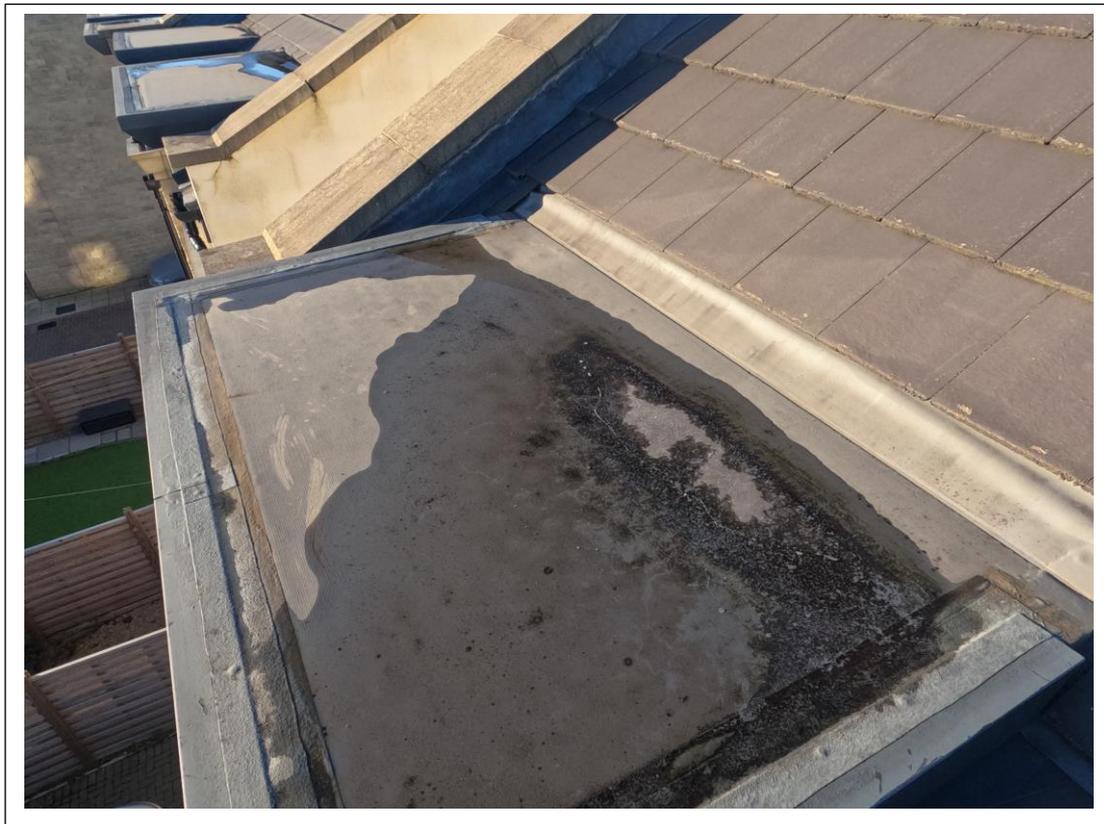
F3 Flat roofs

The flat roof areas are of timber covered in what appears to be fibreglass. I noted no evidence of any damp penetration but the roof areas clearly hold water and will need to be kept clear of moss, leaves and other debris. **CR1**

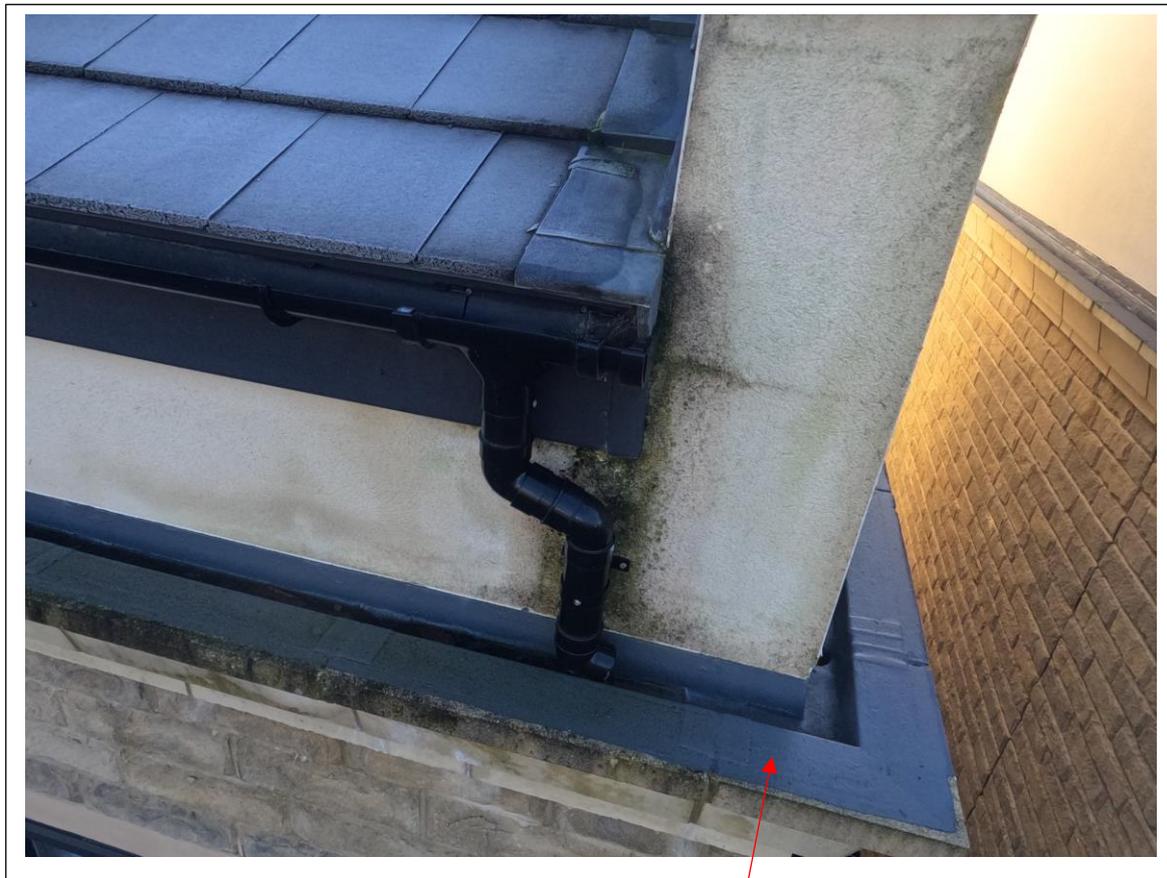
F4 Rain and waste water disposal (above ground – see Section H6 for underground drainage)

It did not rain during my inspection. Rainwater goods are mainly of plastic and should function satisfactorily so long as gutters are regularly cleaned of leaves and other debris. There is evidence, however, that rainwater running of the flashings to the gable parapet (Section F2) is not being adequately diverted to the eaves guttering with resultant staining of the rendered walls below.

Furthermore, there is a rather unusual detail in that the short downspouts from the gutters to the pitched roof discharge into a horizontal perimeter gutter at second floor level. This gutter is formed using sections of imitation stone lined in fibreglass or similar. There are areas of weather staining (see photo below) indicating that rainwater may over-spill in very wet weather and you will need to ensure this guttering is adequately maintained. Downspouts at lower level run to open gulleys and there is similar to a plastic waste pipe from the kitchen. Soil stacks serving the sanitary fittings run within the building where they are concealed from inspection.

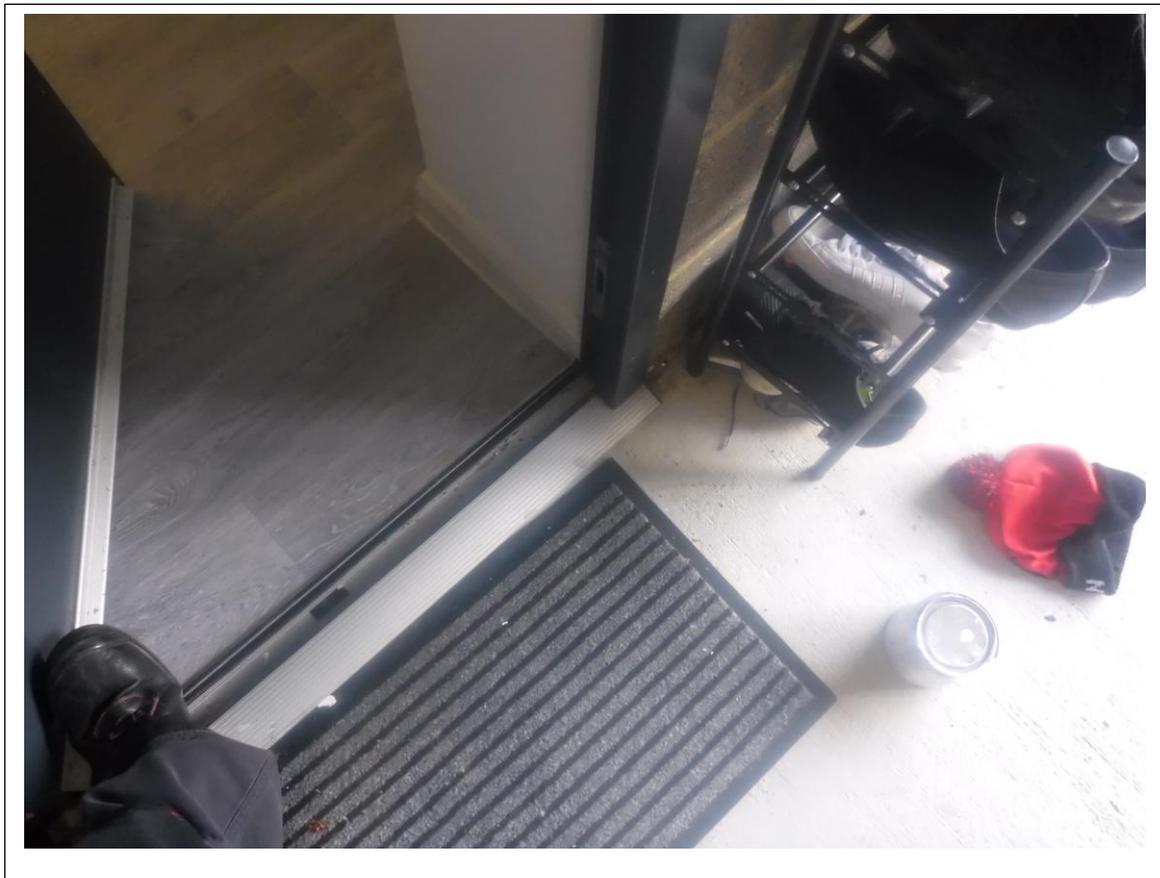
I1 Garage

The garage is integral to the house and, therefore, has largely been covered elsewhere. It is in satisfactory condition for its purpose. The automated roller shutter vehicular door operated satisfactorily and there is a fire-rated pedestrian door giving access to the house. However, there is effectively no change of floor level at the door opening as is normally a Building Regulations requirement.

I assume the design was approved for Building Regulations purposes (Section L1).
