# Home Buyer Survey

Benchmarked to Level 2 RICS Home Survey Standard June 2020

**Date of inspection:** 20<sup>th</sup> April 2023

**Report reference:** 23/\*\*\*\*

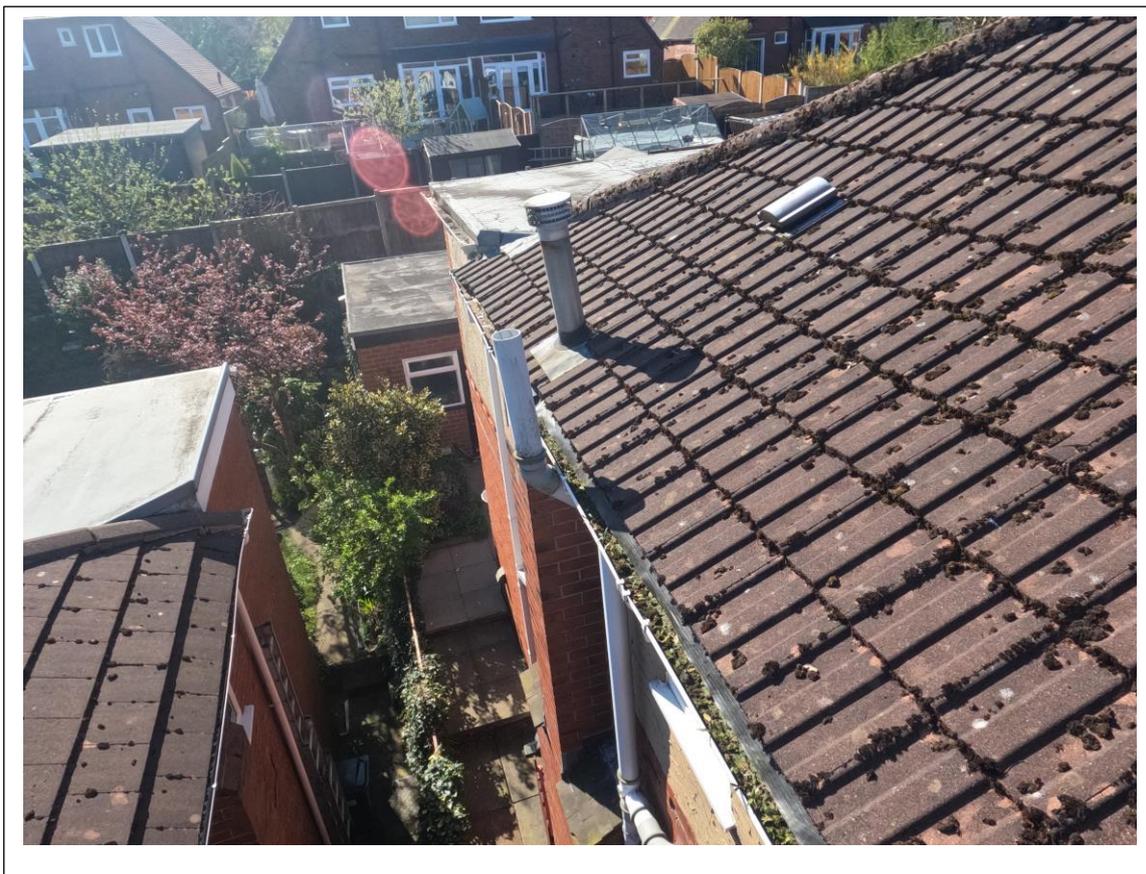
It did not rain during my inspection but rainwater goods are of modern plastic and whilst they require an immediate overhaul in removal of accumulated leaves and other debris (see photo below), there is nothing to indicate that they will not function adequately so long as they are regularly maintained.

You may, however, find that some of the gutter joints drip following rain and require sealing. The downspout from the front bay discharges into the garden where rainwater is likely to cascade down the steps and onto the public highway. This is not ideal, and could prove dangerous during freezing weather, and you may wish to have a gully and drain provided and linked to the inspection chamber on the side footpath (Section H6). Downspouts to the side and rear run into open gullies with the one to the rear also serving a plastic waste pipe from the kitchen. The plastic soil stack serving the bathroom fittings is in satisfactory condition although a cage should really be fitted to the open top end (see photo above) to prevent entry by leaves and other debris. **CR3**

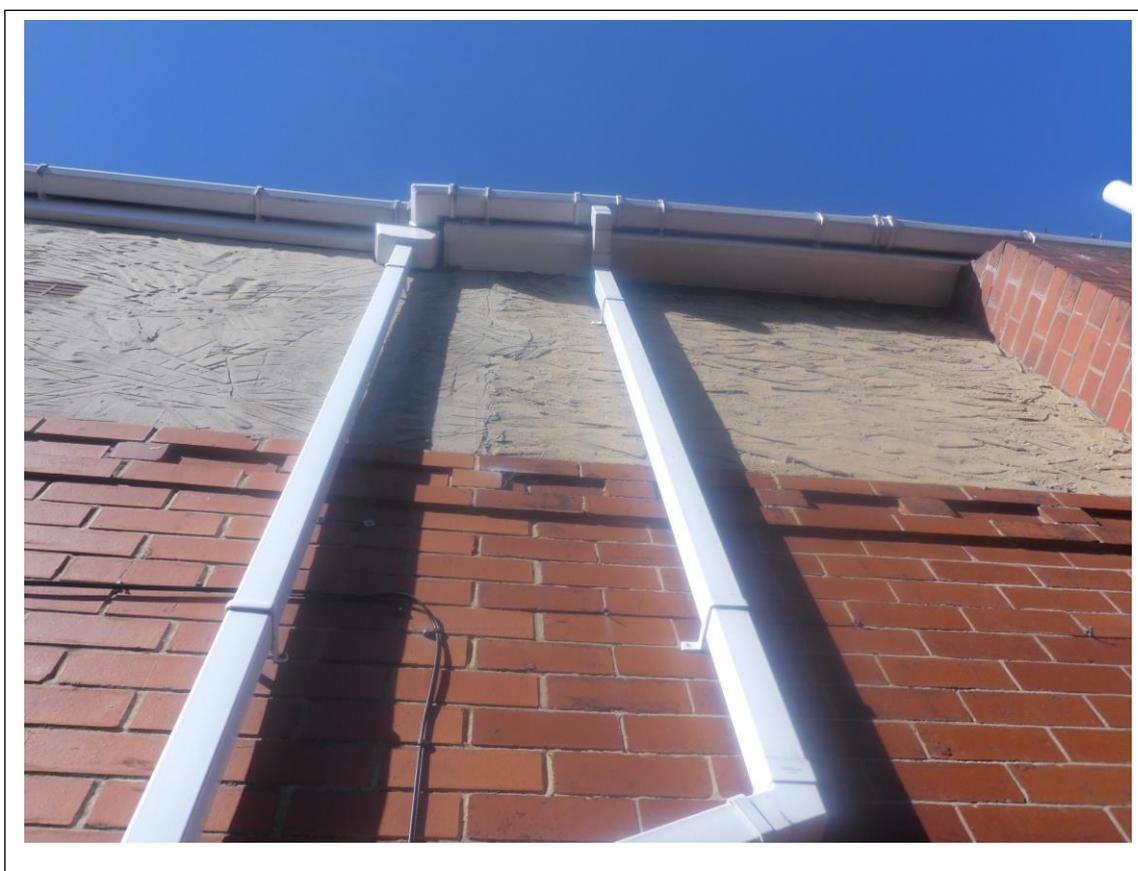
Elevations are of cavity brick (the inner leaf to the cavity walls to the extension is probably of concrete block) with the upper front and side walls having a trowelled sand and cement render finish to which there is some flaking paintwork at the front but no decorative finishing to the side. Galvanised steel lintels support loads over door and window openings to the extension. There is nothing to indicate any deficiency in the provision of lintels to the openings to the original house. There is no significant cracking or distortion to indicate foundation problems or ground movement. There is some old cracking in the rendering at the point where the extension was built out from the original house.

This crack is of no structural concern but it should really be filled if safe access can be made available and the rendering should then be brushed and painted. Brickwork remains in satisfactory condition although pointing is of mixed age and is now becoming rather worn in parts and you should budget for repointing to be undertaken where necessary as a medium-term repairing liability. It would also be prudent to have the condition of the cavity wall ties to the remaining original elevations checked as part of such work as it is known that many of the wall ties used in the early post-war period were of fairly poor quality and may have a limited remaining life expectancy (see enclosed *Cavity Wall Tie Reference Sheet*). In any event, even if the ties are not particularly weakened by corrosion, they are likely to be few in number

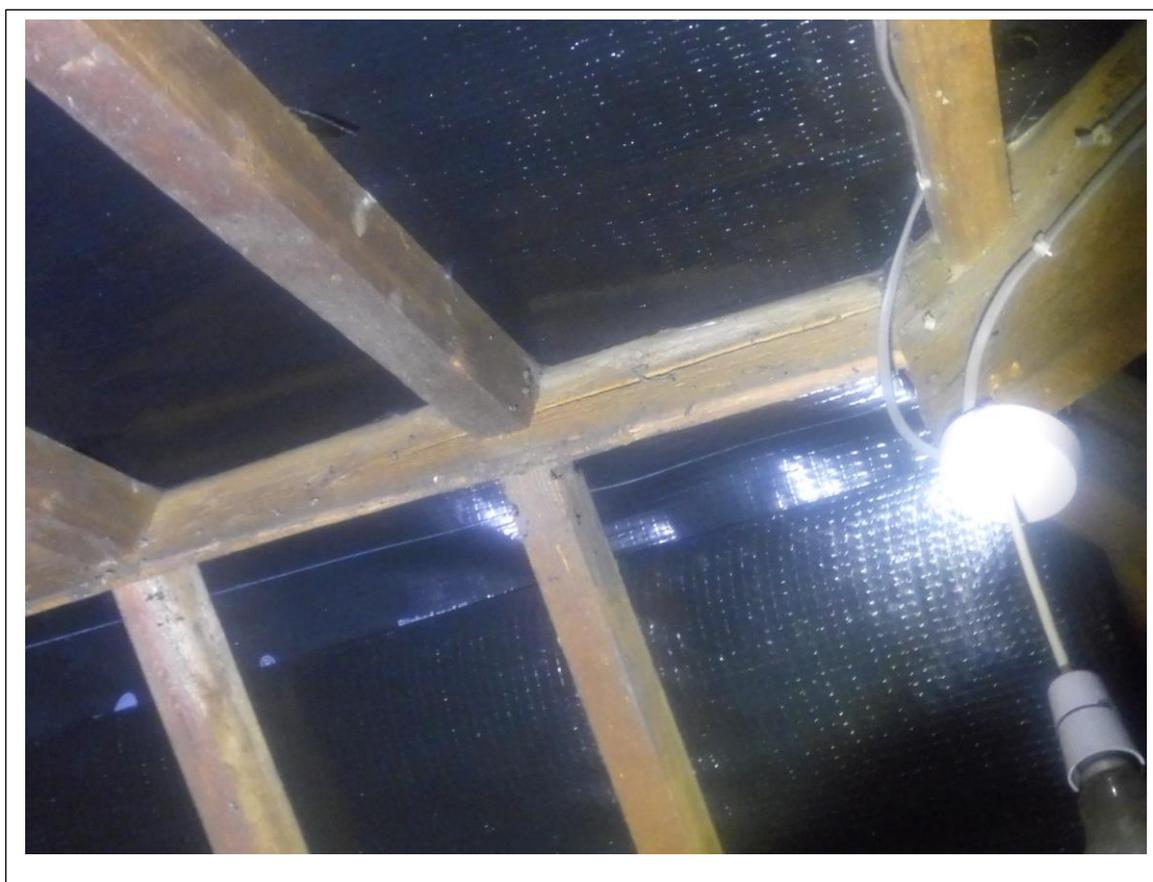
The roof is framed in timber in a conventional manner. Timbers are adequately sized and supported for normal loading and showed no significant deflection or distortion, whilst noting that the replacement roof covering is probably slightly heavier than the original (Section F2), but there is a slight split in the end of the rather thin ridge board where it meets the heads of the hips that run to the outside corners.

There is no evidence of recent movement but it would be prudent to glue and plate the split section of timber. I could see no evidence of rot, disease or beetle infestation. There is a reinforced plastic membrane providing a secondary weatherproofing barrier beneath the tiles. This type of material does tend to be cold and to “sweat” during cold weather due to condensation (see *Appendix C*) but this appears to have been identified by the roofing

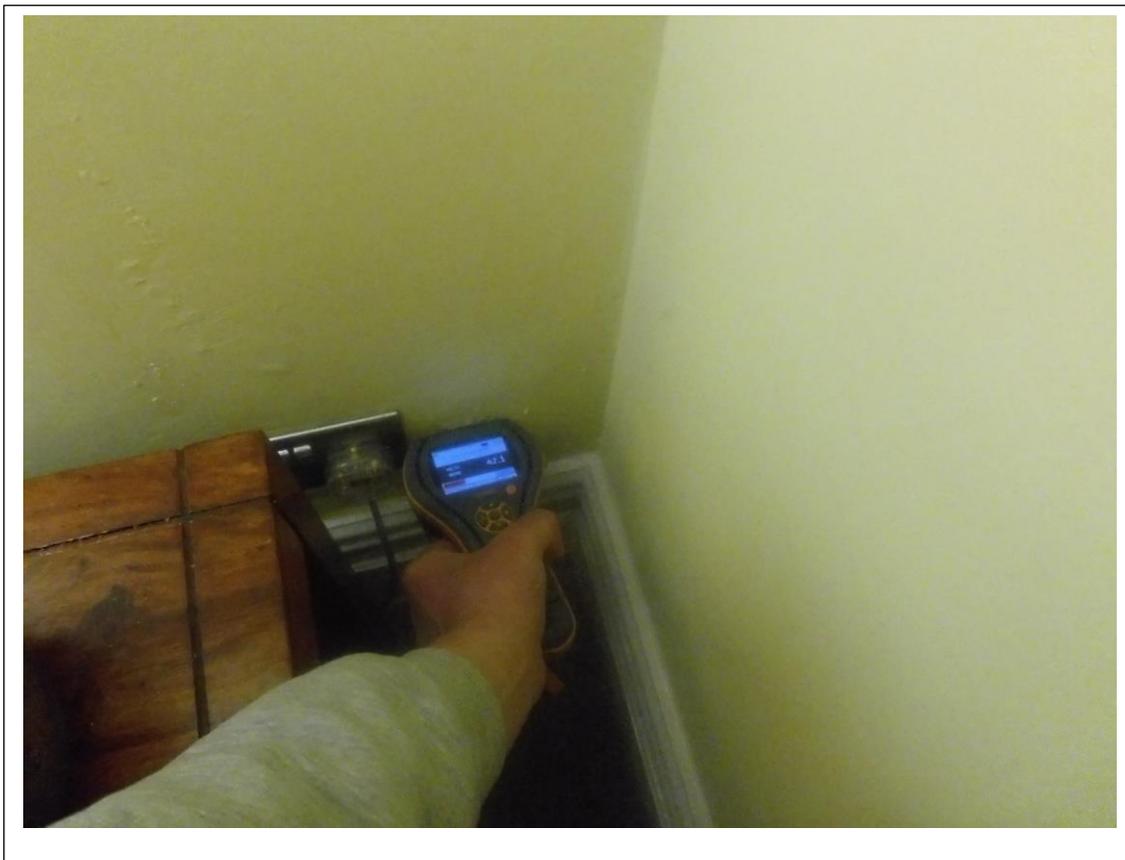
Walls are mainly of plastered brick or concrete blockwork and selective testing revealed plaster to be in generally sound condition but you may find some cracked or loose plaster requiring repair during future redecoration. There are some sections of lightweight timber and plasterboard partitioning at first floor level. To the ground floor accommodation, random testing of accessible parts of the lower internal walls and skirting boards using an electric conductance meter produced normal readings in virtually all areas indicating that damp proof courses are still functioning effectively. There is one small area of concern to the rear right hand corner in the original part of the dining room where high readings were recorded in plaster and where there is some flaking paintwork (see photo on page 21). This would originally have been an external cavity wall and I suspect that the damp proof course may have been bridged by debris allowed to drop into the cavity when the extension was constructed. No immediate action is considered necessary but it would be prudent to have this wall area opened up at some stage so that debris can be cleared out and a new section of damp proof course inserted if necessary. **CR2**

*Localised area of dampness*

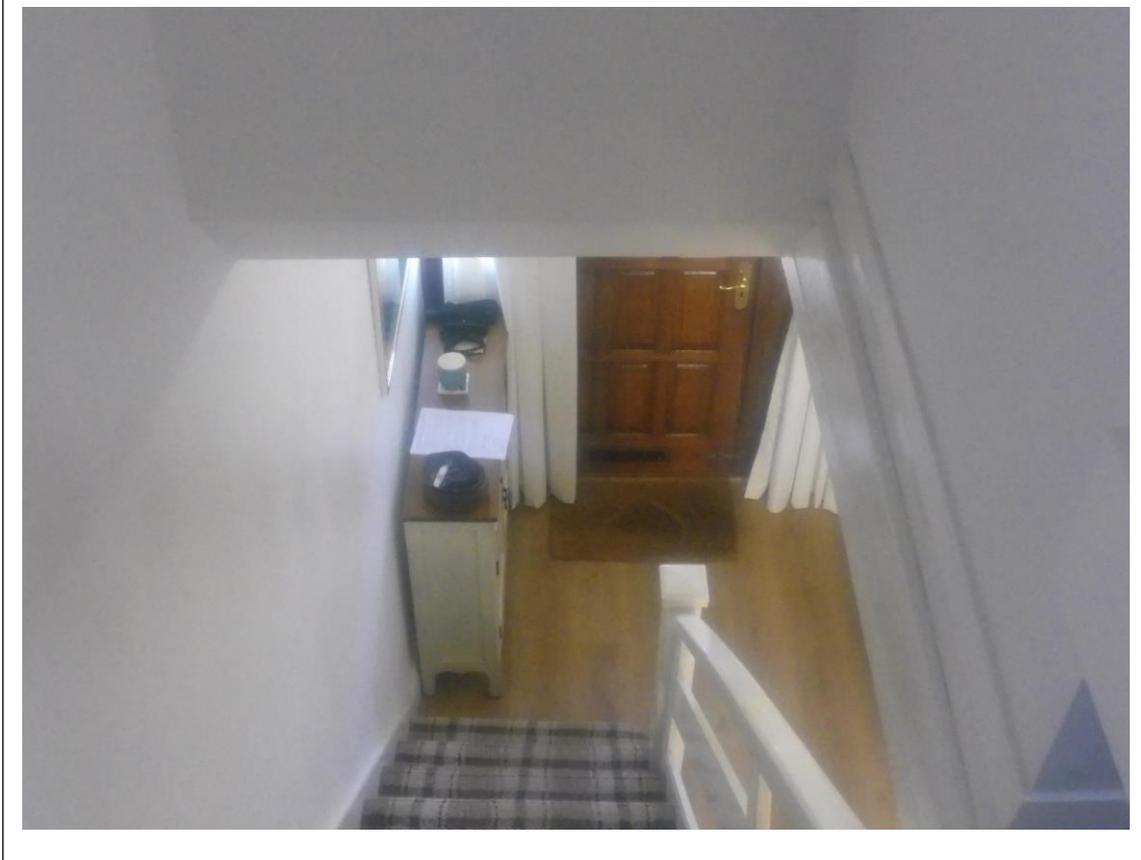
Mixed age gloss painted and stained timber skirting boards, door frames and window sills are in satisfactory condition, as are the modern oak panel doors. The part open plan staircase has some safety issues as there are timber ranch style balustrades that could easily be climbed by

young children and there is also only around 1.5 metres headroom over the middle part of the flight beneath the projecting first floor structure.

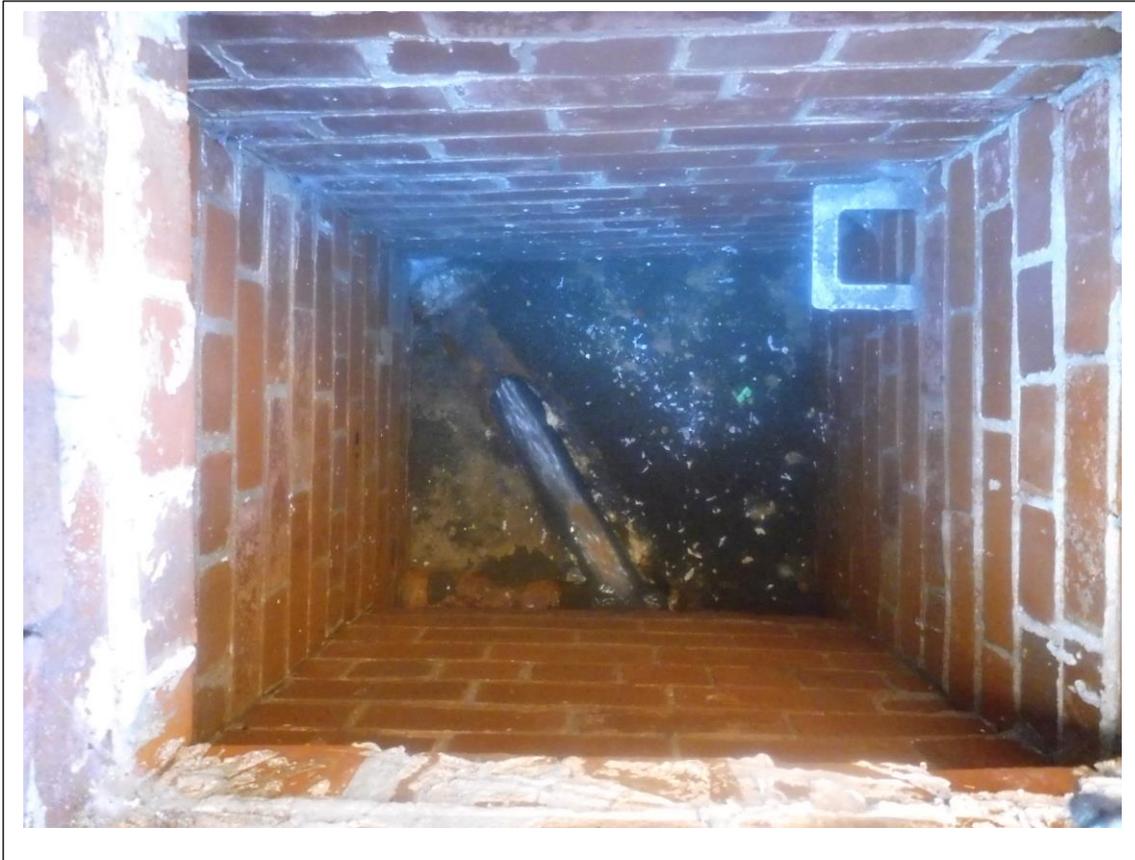
The property will connect to the public sewer and I lifted the rusting cast iron cover to a fairly deep brick manhole (see photo on page 27) on the side footpath and over an angled section of foul drain (although rainwater probably connects to the same system) at the base of the soil stack. The drain probably drops into a lower-level system at the neighbouring house. A free flow of water was obtained at a good rate of flow and with no signs of backing up or blockage but there is some accumulated dirt and debris on the concrete benching to either side of the drainage channel. The chamber should be hosed clean and disinfected although the benching should really be re-formed so that it inclines towards the drain. **CR2**

*The drainage manhole*

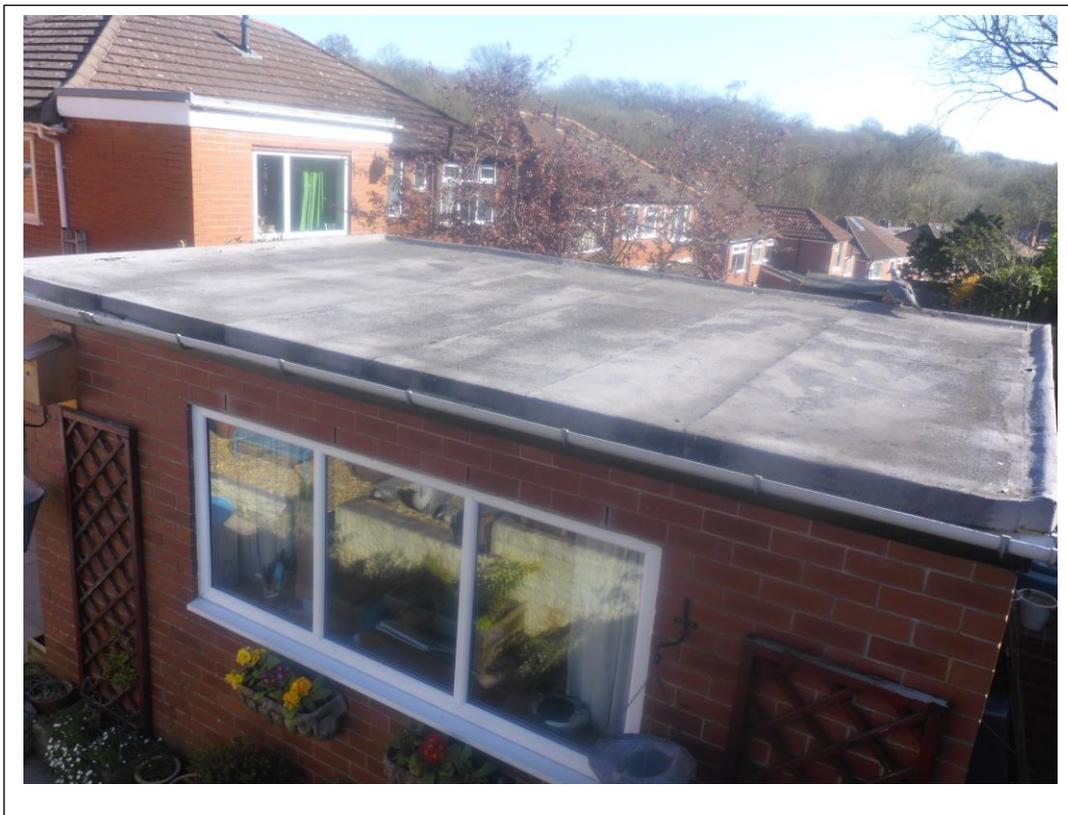
The detached outbuilding is of fairly substantial cavity brick and concrete block construction with a plastic strip damp proof course and there are galvanised steel lintels over the door and window openings. Pointing to the brickwork is becoming a little worn and will require attention at some stage. The side window is a fairly modern double glazed UPVC frame in satisfactory condition. There is a hardwood panel door in a timber frame, where there is some rot at low level, adjacent to a 6mm double glazed timber window that is not visibly marked as being of toughened glass (see Section F7) and you may wish to budget for early replacement of these components. The flat roof is of timber and old felt, which is rather rippled and uneven (see photo on page 30). Similar comments apply as in respect of the flat roof on the extension (Section F3) and you should budget accordingly. There is, in fact, some faint water marking to the rear section of the plasterboard ceiling indicating that there has been some water penetration through this roof in the past. It has a rather limited fall to plastic rainwater goods that discharge into an open gully along with a plastic waste pipe from an internal sink and plumbing from an automatic washing machine. There are various minor cracks to internal wall plaster but these are not of structural concern. **CR2**

*The outbuilding flat roof*
