## **Building Survey Report**

**Benchmarked to Level 3 – RICS Home Survey Standards 2020**

Date of report: 17<sup>th</sup> October 2023

Report reference: JB/AH 23/\*\*\*\*

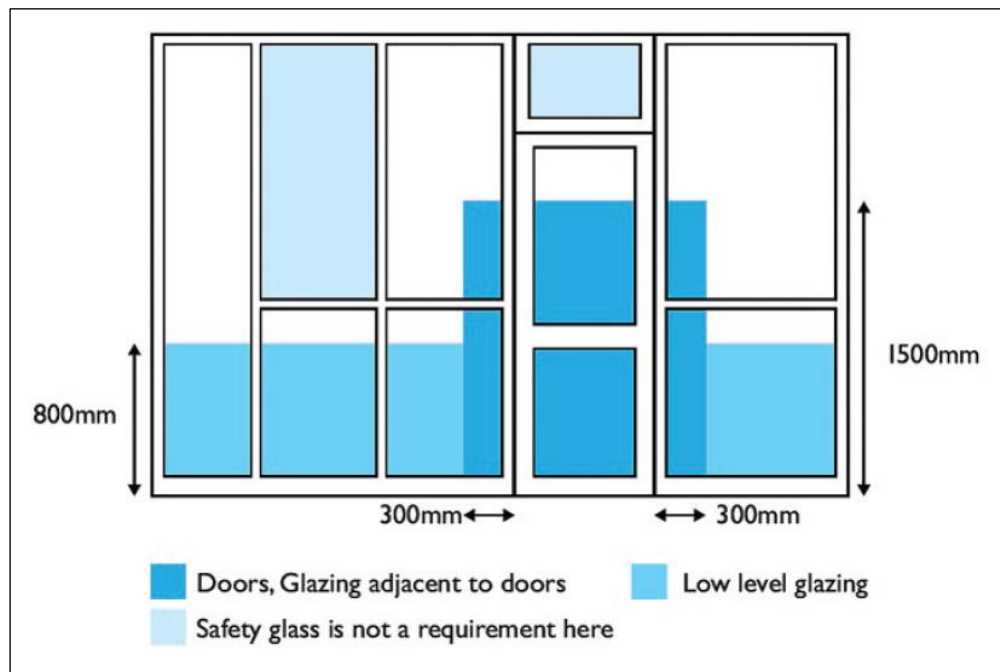
Entry to the front vestibule is by way of timber double doors with large single glazed panels and hung in a matching surround. The components are in reasonable condition although the doors are not the tightest of fits when closed and the single glazing is likely to be prone to internal condensation (see enclosed **Condensation Reference Sheet**) as it will act as a dehumidifier. You should also note that the glazing is not of a safety type as would now be required.

The cheapest option for the time being will be to apply self-adhesive safety film but you may wish to budget for early installation of replacement components fitted with double glazing and complying with current Building Regulations in terms of safety and thermal performance. Similar comments apply in respect of the similar doors to the rear extension where the glazing is even more dangerous as it extends almost down to internal floor level. These doors are in fair condition but show wear and tear commensurate with age and some rotten sections have been repaired using filling compound. One of the doors has a cracked glass panel.

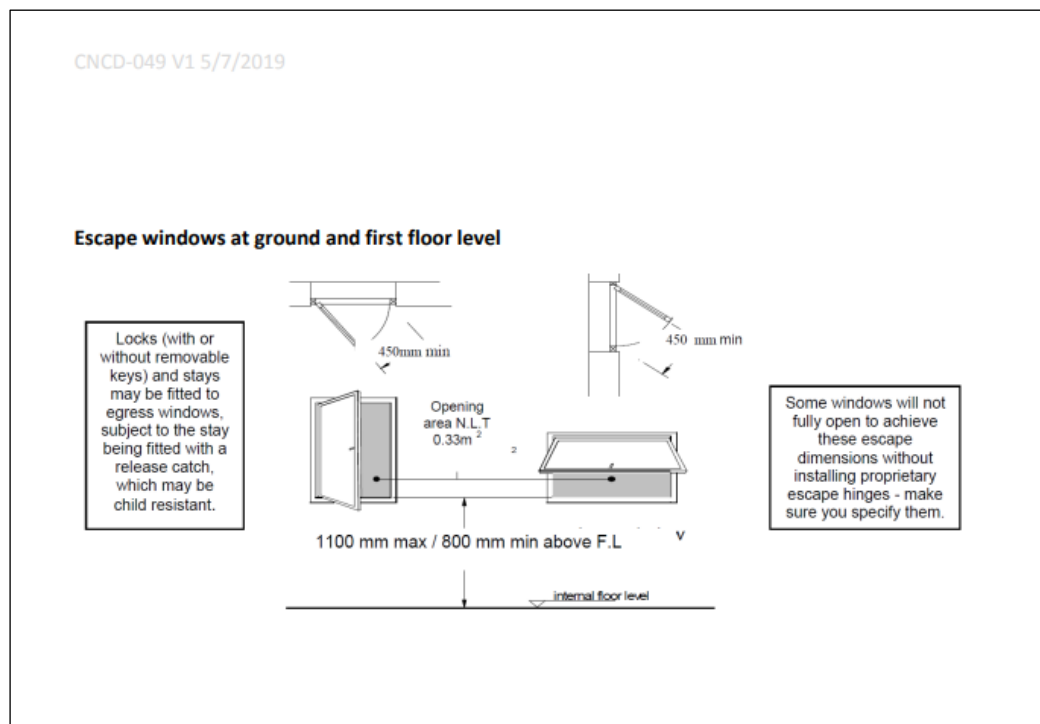
These are old, mainly original, single glazed timber frames in variable but generally poor condition and whilst I understand you had no immediate plans for their replacement with more energy-efficient double-glazed components, you should really budget for such to be undertaken before too long as the windows are really at the ends of their serviceable lives. The windows will clearly be draughty, and prone to excess heat loss and condensation. They also fall a long way short of current Building Regulations standards in terms of thermal performance and lack safety glazing in the critical locations (see diagram under Section 9.9). None of the opening lights to the ground floor windows presently opens and whilst some of the lights to the first-floor windows will open to allow for ventilation, others are stuck and/or painted shut including the two lights that should provide a means of escape from the larger front bedroom (75) in the event of fire. Neither of the windows to the smaller front bedroom meets current Building Regulations standards in terms of emergency escape (see diagram below). Furthermore, the low-level sill to the landing window adjacent to the staircase (72) could easily be accessed by young children.

The timber frames have varying degrees of rot that is not concealed by paintwork and there have been numerous past attempts of repair by splicing of new sections of timber and use of filling compound (25-27).
