# Home Buyer Survey

Benchmarked to Level 2 RICS Home Survey Standard June 2020

**Date of inspection:** 20<sup>th</sup> April 2023

**Report reference:** 23/\*\*\*\*

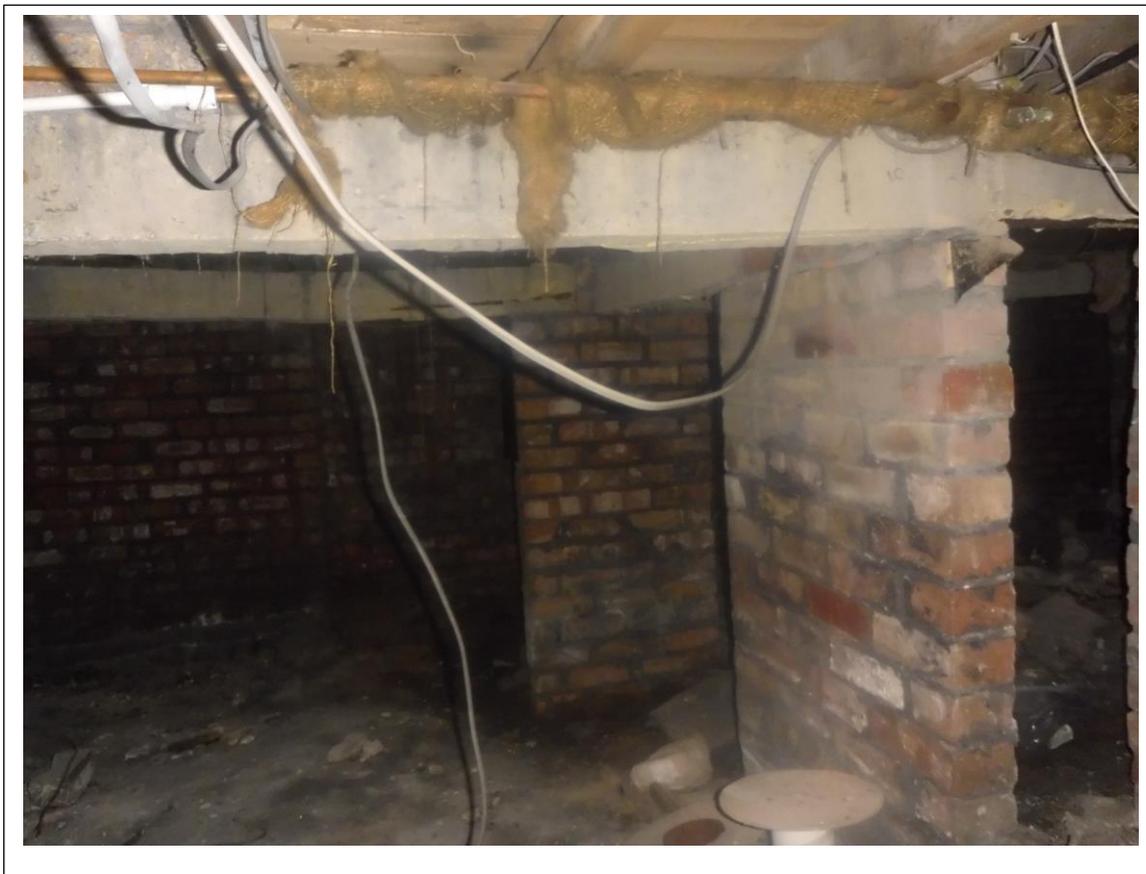
ventilated conditions, but I could not see any evidence of decay or beetle infestation. **CR1 – limited inspection.**

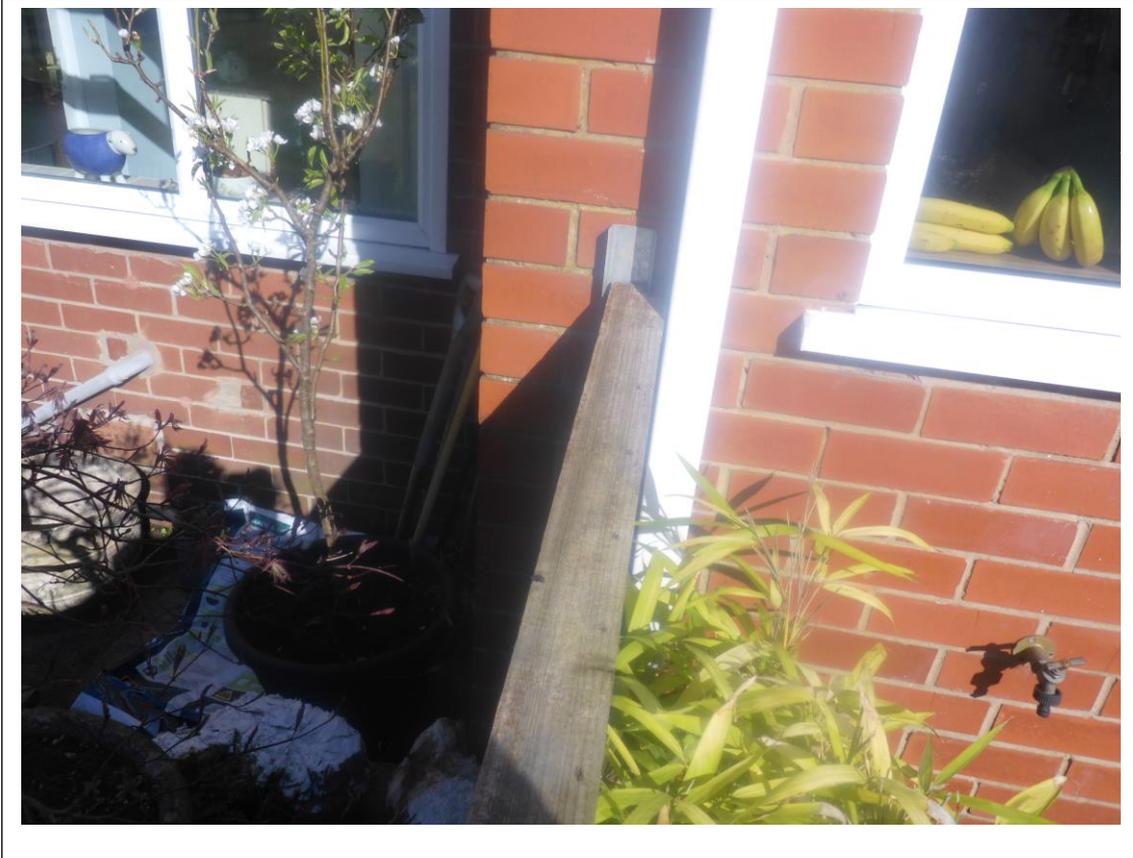
rear garden is set slightly off line relative to the corner of the extension and your Legal Adviser should confirm that there have been no boundary encroachments (Section L3). **CR1**
